### **RE: Community Provision at Shephall View - 22/00965/FPM**

Condition Schedule  
Photographic Condition Schedule

Stevenage Sea Cadet Building, Shephall View, Stevenage, SG1 1RP

Property – 37 Shephall View, 5<sup>th</sup> Scout Hut Building, Stevenage SG1 1RL

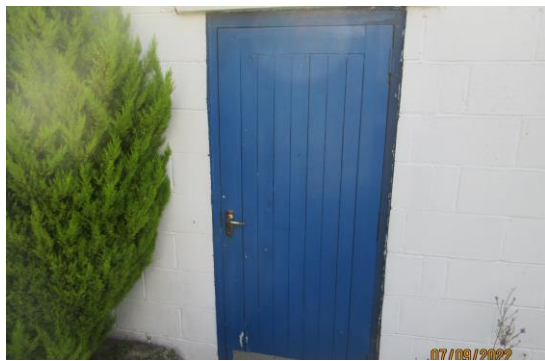
Photo 2 – Mortar joints to blockwork cracked and falling out.

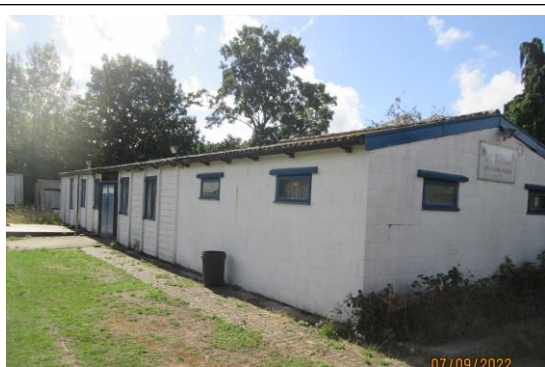
Photo 4 – Blockwork cracked adjacent to window

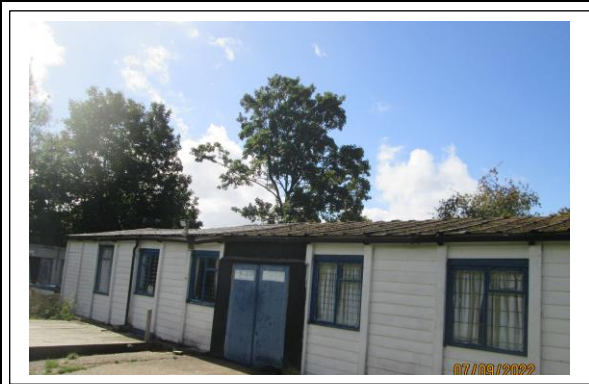
Photo 6 – Cracked glazing to window

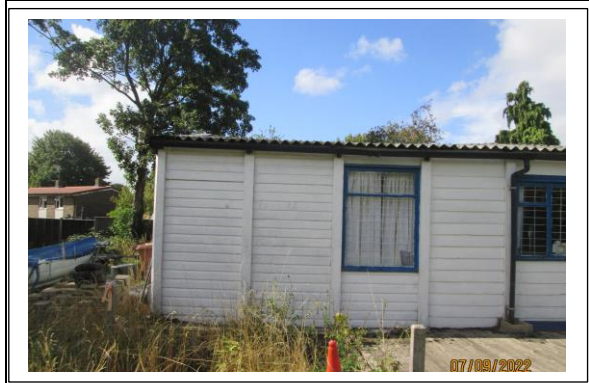
Photo 11 – Gutter unsupported and leaking

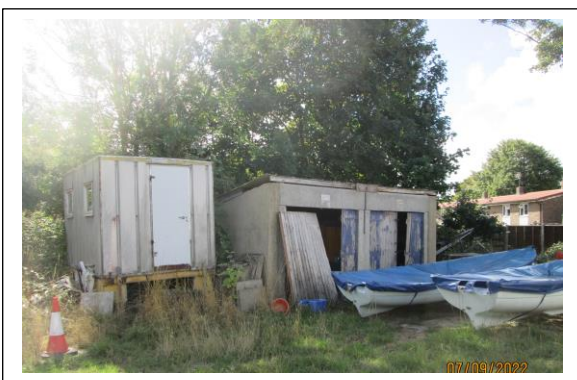
Photo 12 – Concrete panels damaged

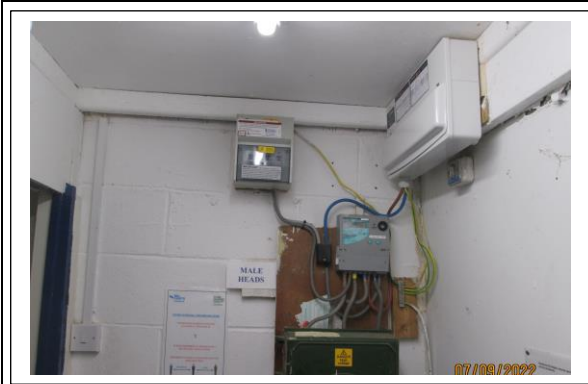
Photo 24 – Electric supply head leaking bitumin due to overheating

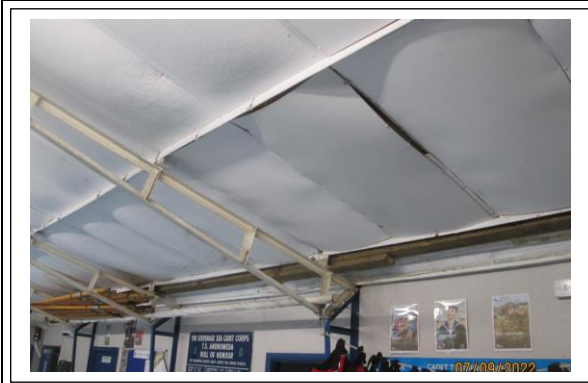
Photo 28 – Damaged ceiling panel and corrosion to steel truss

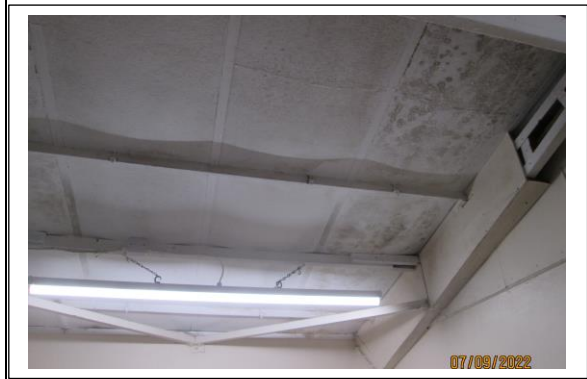
Photo 33 – Evidence of water ingress at eaves

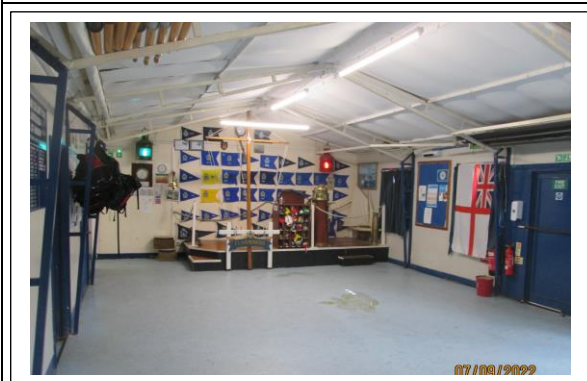
Photo 34 – Ceiling panels water stained and bowed

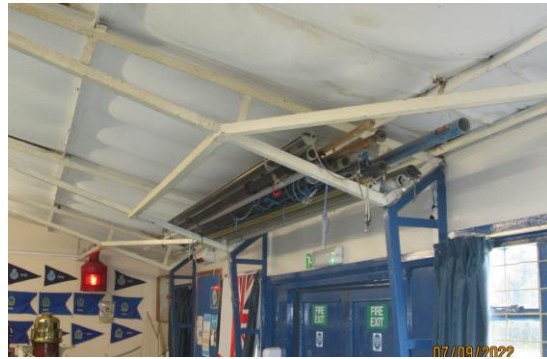
Photo 36 – Electrical heater and spur position below leaking roof

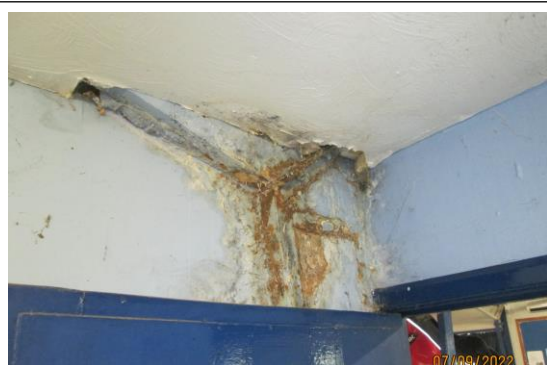
Photo 40 – Extensive damp ingress behind door causing plaster to de-bond

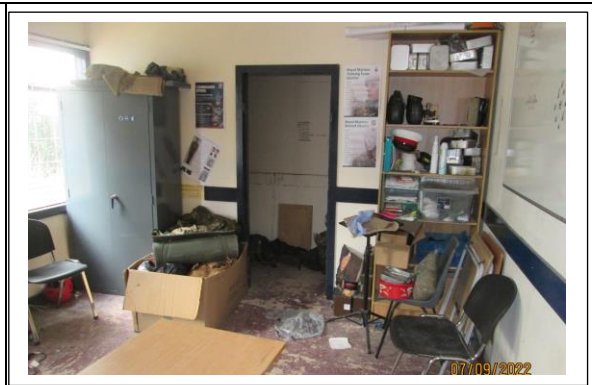
Photo 43 – Floor paint worn and floor screed in poor condition

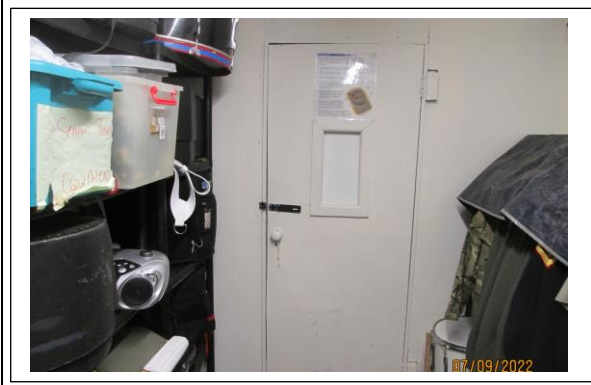
Photo 44 – Storage room door removed and floor uneven with paint worn

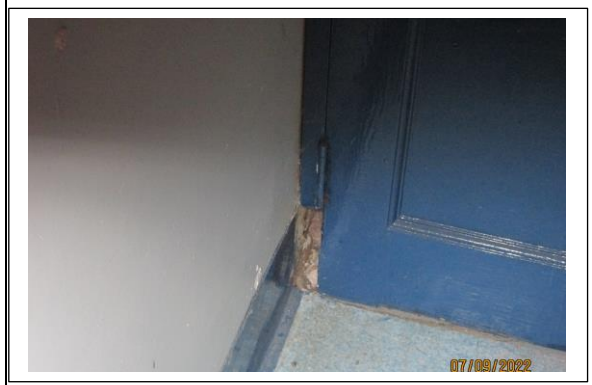
Photo 45 – Door damaged
