# Stevenage Borough BM Inspection form V1

10 Jun 2024

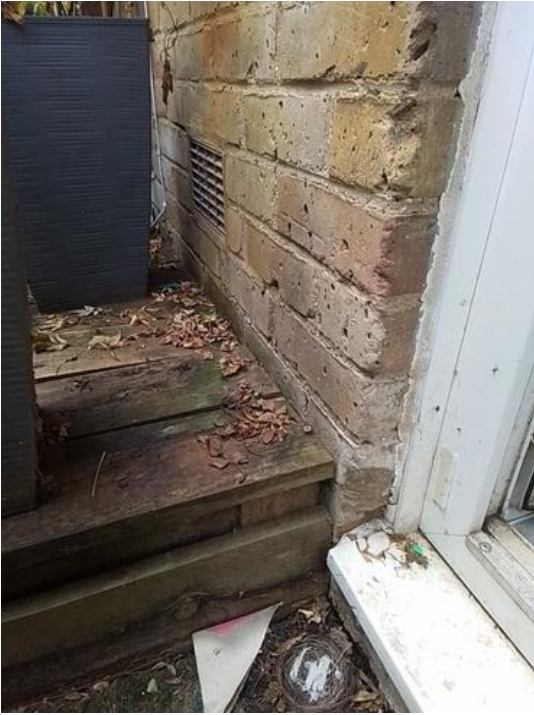
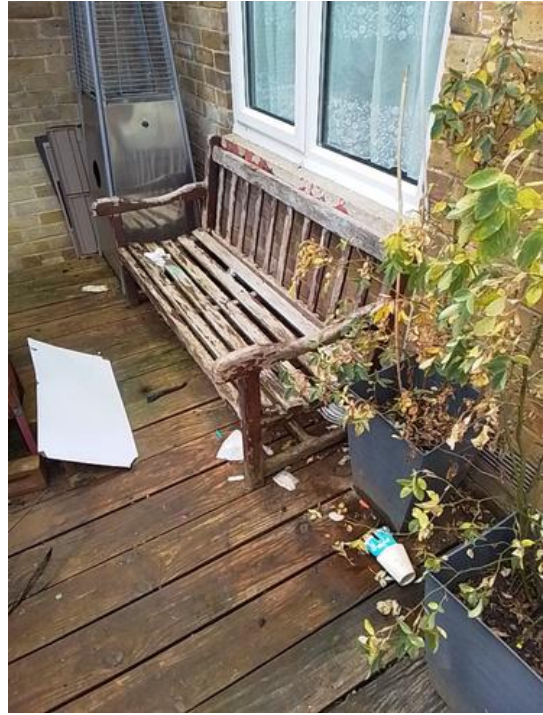
Is there any breaches/bridges of DPC?

Yes

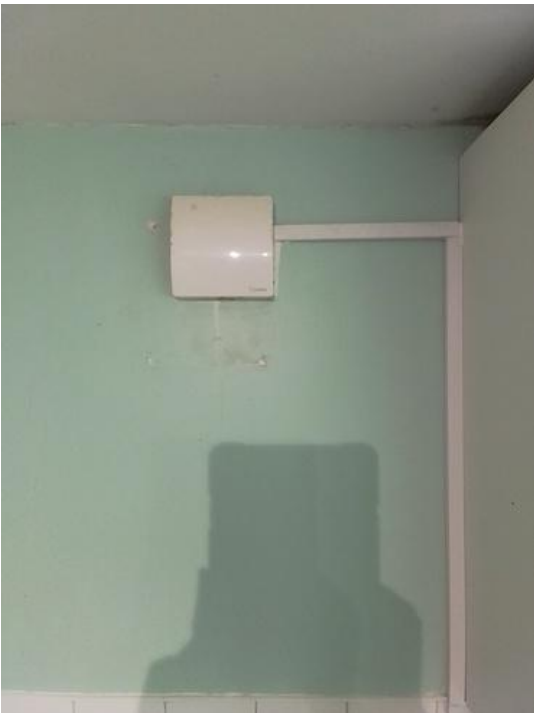
Photo 3

**Is there an extractor fan installed and working?**

Yes

Overhaul fan x1, stage 3 ceiling 2.6x4.5m2. 3m2 plasterboard ceiling, skim ceiling 3m2 , emulsion ceiling 5m2, stage 3 to cold wall, stage 2 wash window and door 5m2, possibly take units off wall, regrout tiles x 4m2, sealant windows 12lm, skim wall 2m2

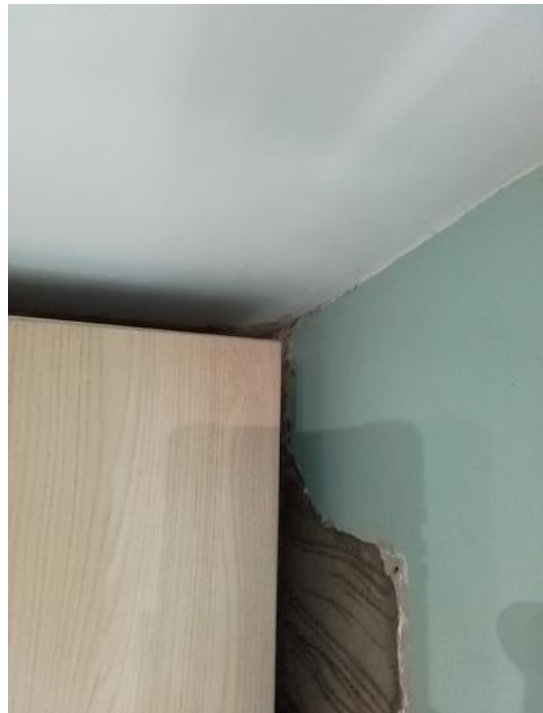
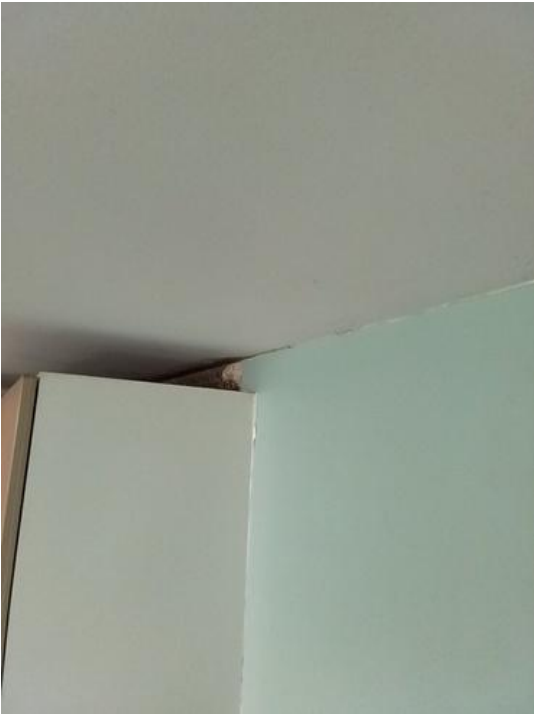
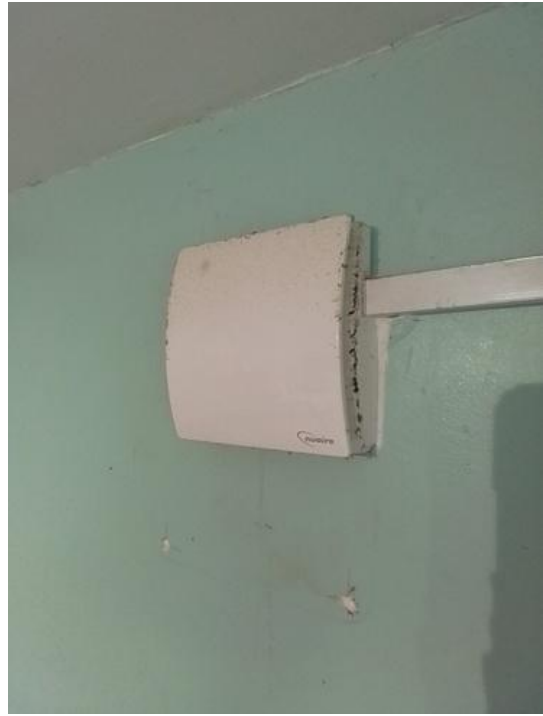
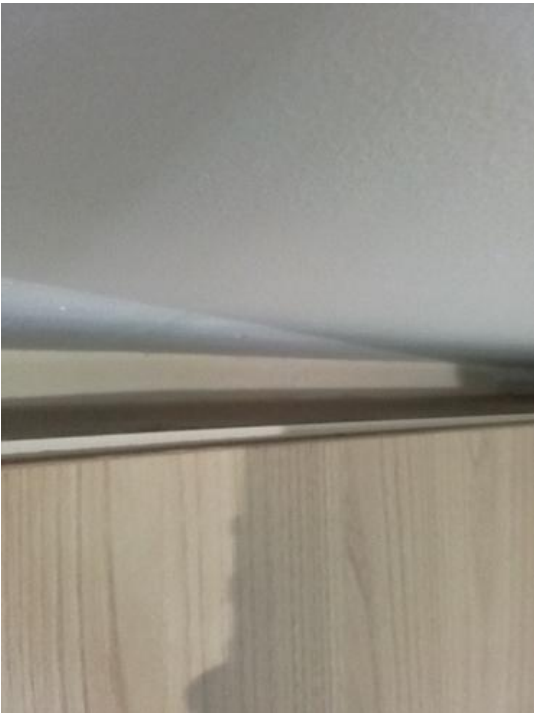
**Is there signs of damp or mould**

Yes

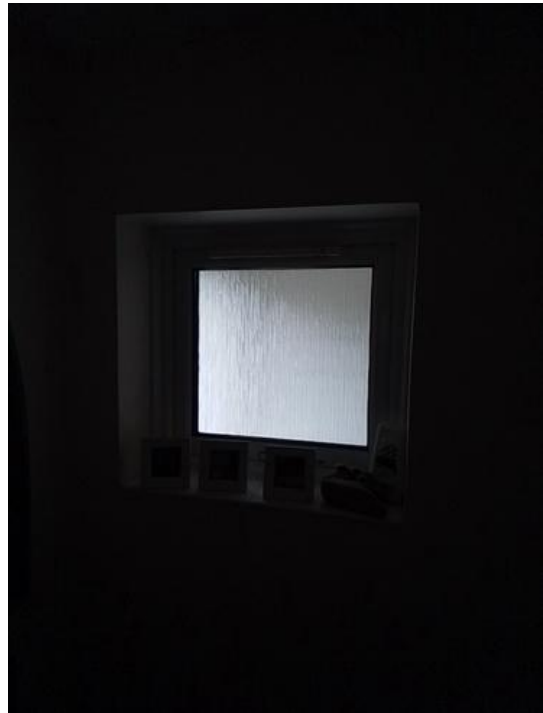
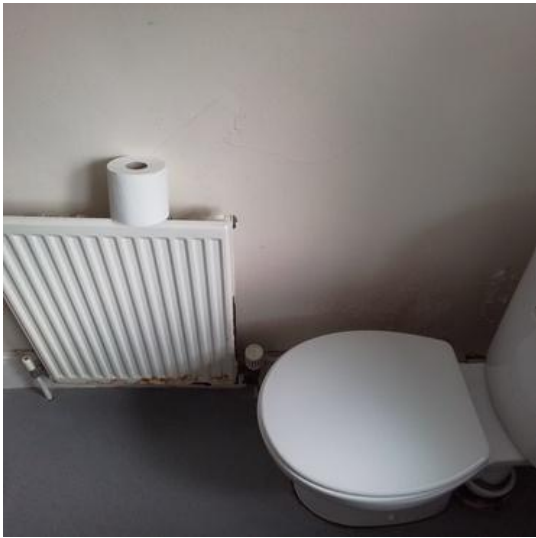
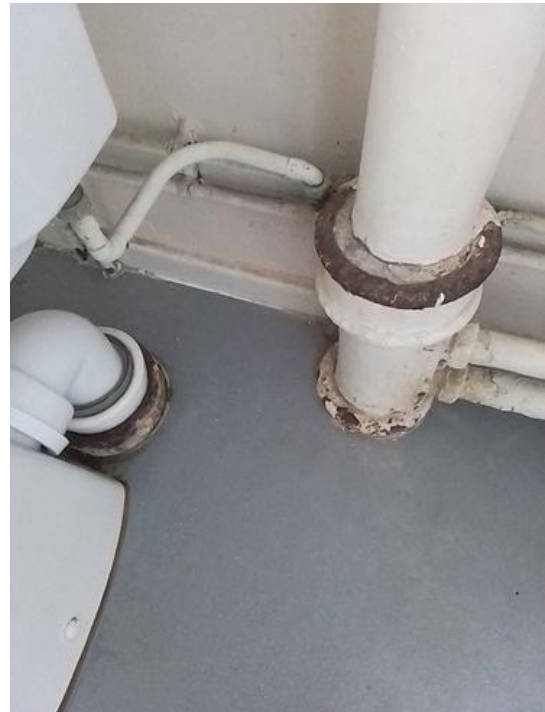
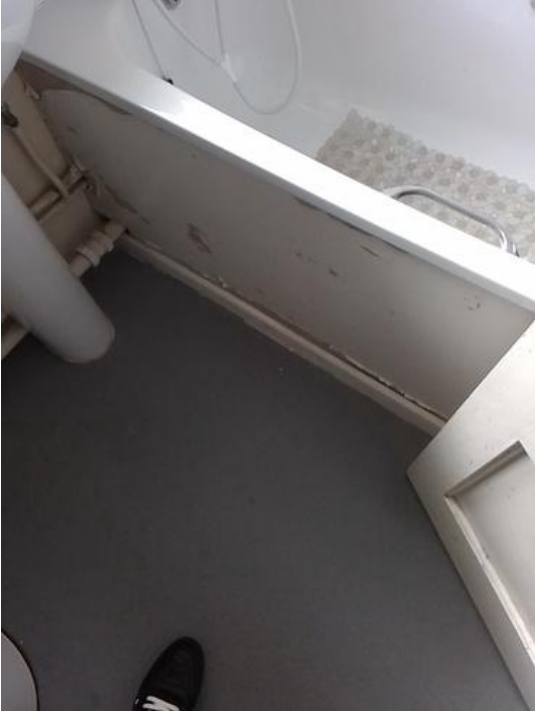
**Is there an extraction fan installed and working?**

No

Air brick x1 or fan circuit vent in downstairs WC/ repair team work required in bathroom

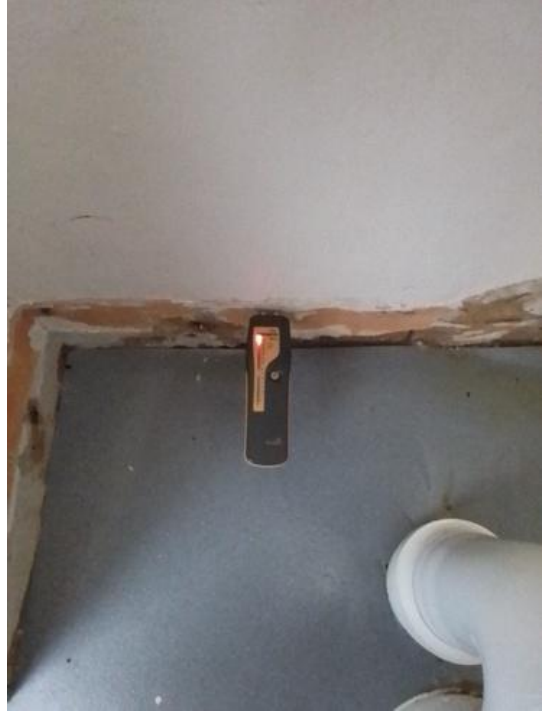
Photo 15

**Is there signs of damp or mould**

Yes

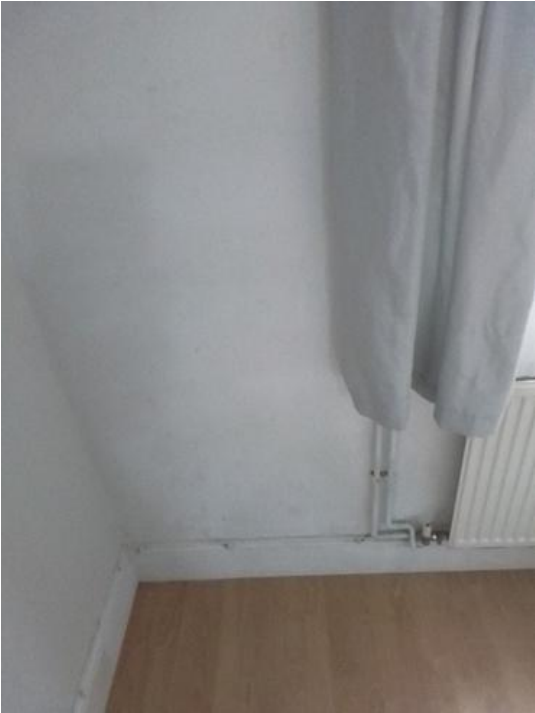
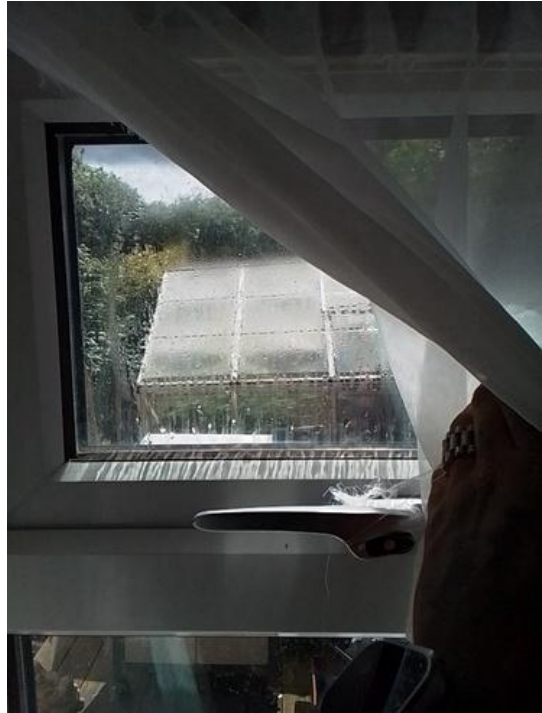
**Is there signs of damp or mould**

Yes

Stage 3 cold wall and rhd party wall, 6.2x 2.4m2, + 3X2.4 MHEV FAN.? Strip paper x 0.5

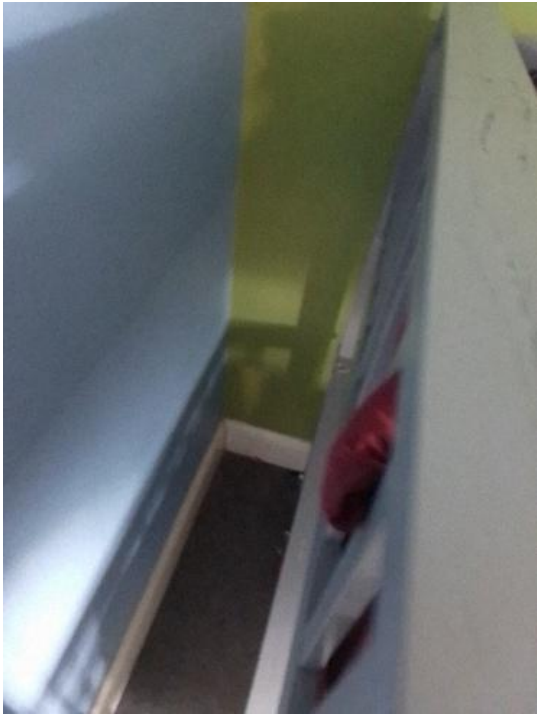
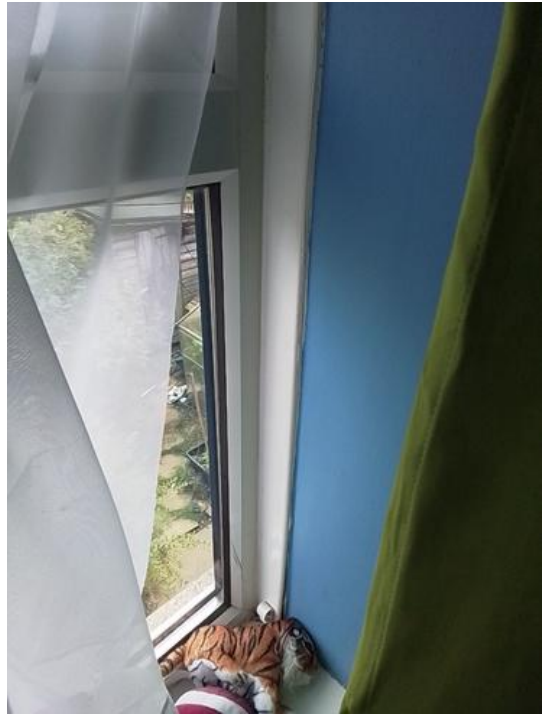
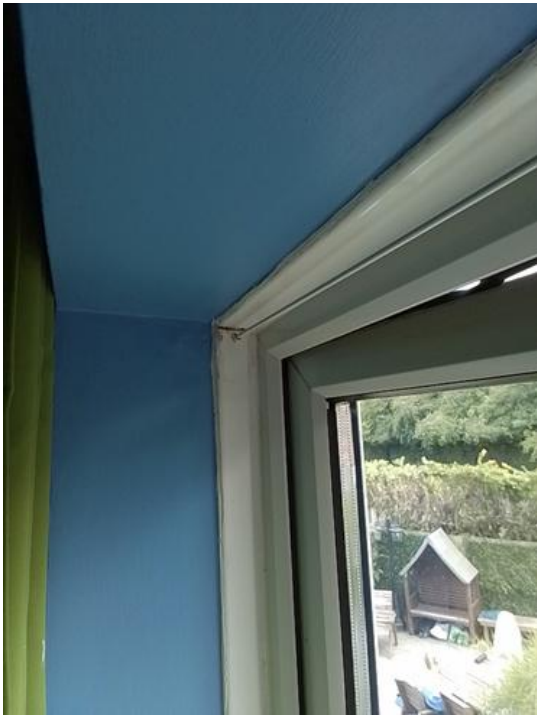
**Is there signs of damp or mould?**

Yes

Vent from piv, stage 2 to window 2m2
