### **RE: Community Provision at Shephall View - 22/00965/FPM**

Condition Schedule  
Photographic Condition Schedule

Stevenage Sea Cadet Building, Shephall View, Stevenage, SG1 1RP

Property – 37 Shephall View, 5<sup>th</sup> Scout Hut Building, Stevenage SG1 1RL

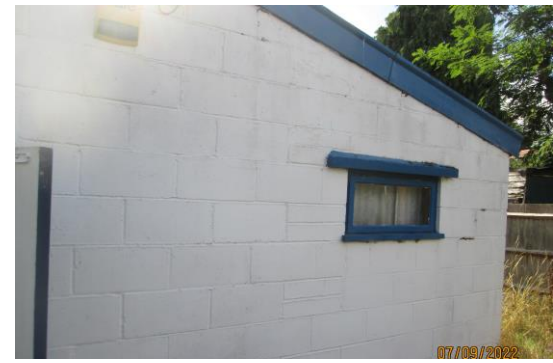
Photo 2 – Mortar joints to blockwork cracked and falling out.

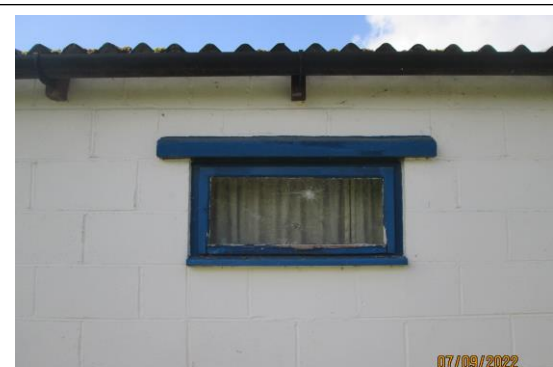
Photo 6 – Cracked glazing to window

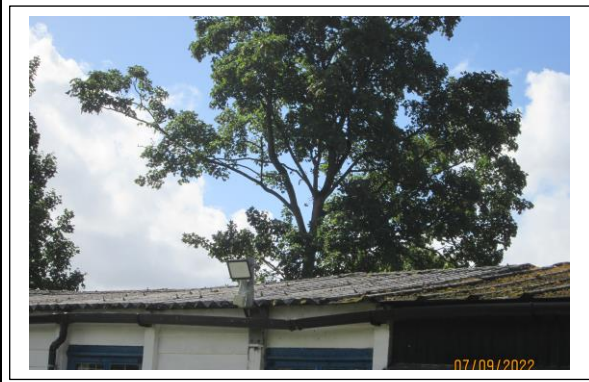
Photo 9 – Poor weathering detail at roof junction

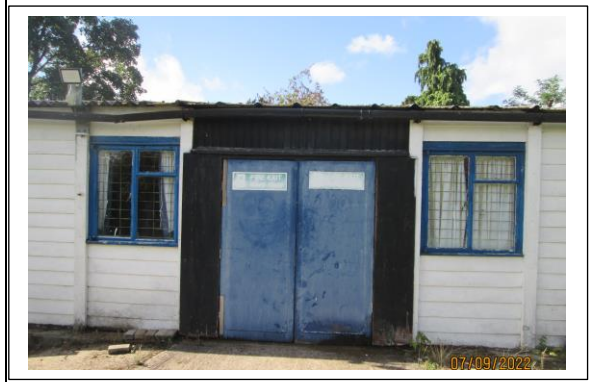
Photo 10 – Fire exit doors and timber panels rotting at low level

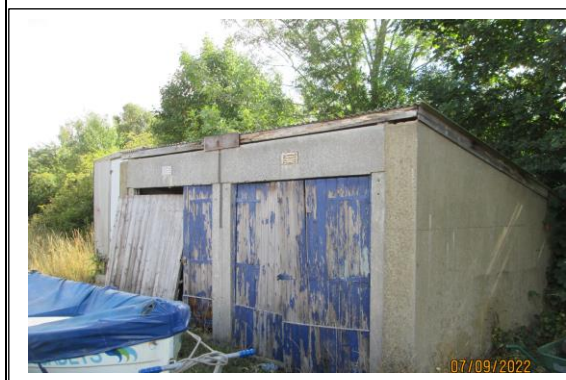
Photo 14 – Rotting timber doors and fascia

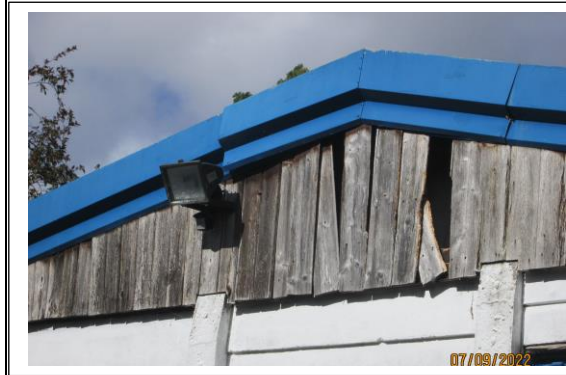
Photo 16 – Timber cladding rotted and falling out

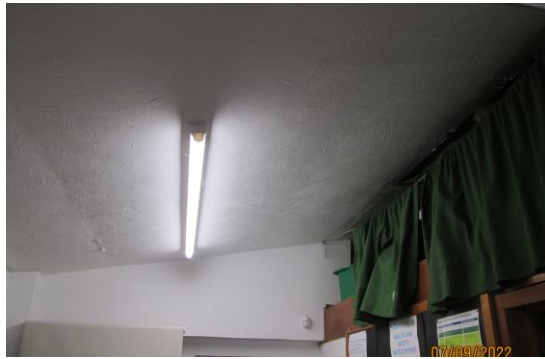
Photo 19 – Artex ceiling finish flaking

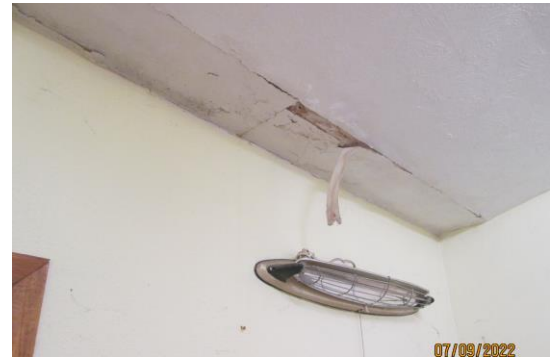
Photo 20 – Ceiling edge detail falling away due to water ingress

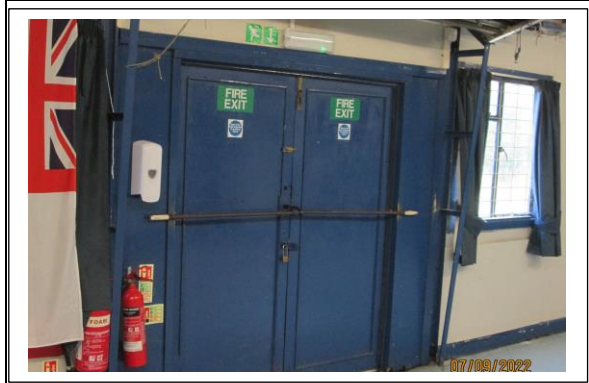
Photo 30 – Fire exit doors with obsolete panic bars

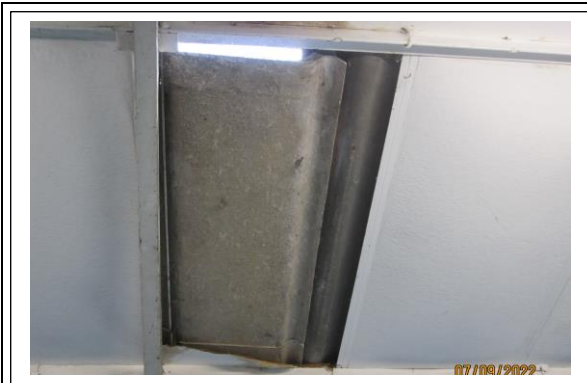
Photo 31 – Large gap in main roof

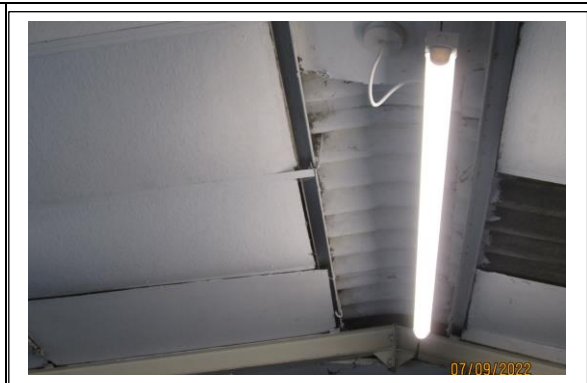
Photo 32 – Evidence of water ingress below ridge detail

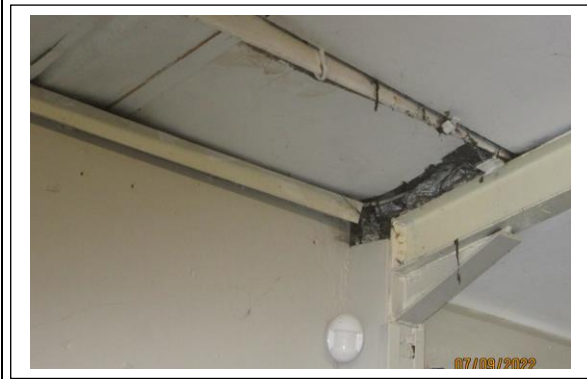
Photo 33 – Evidence of water ingress at eaves

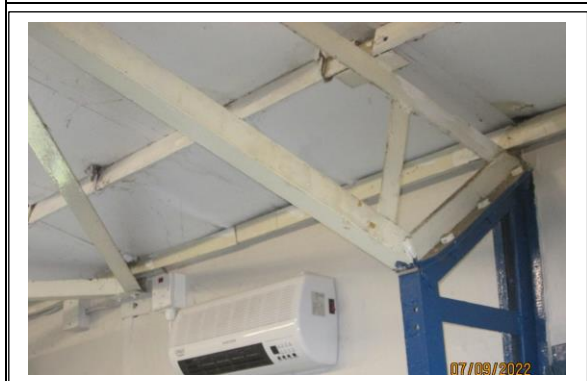
Photo 36 – Electrical heater and spur position below leaking roof

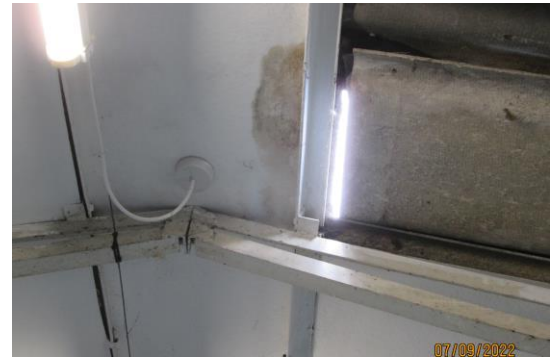
Photo 38 – Electric light ceiling rose close to area of water ingress

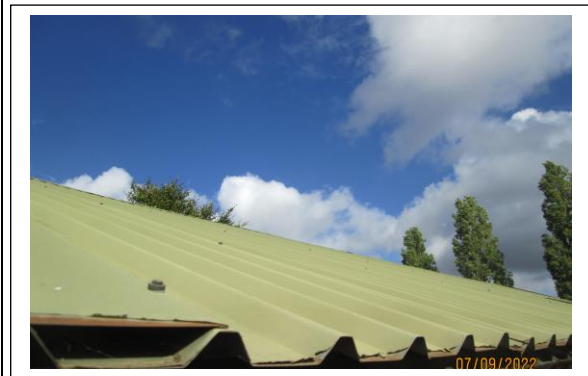
Photo 3 – Profile metal roof with cut edge corrosion

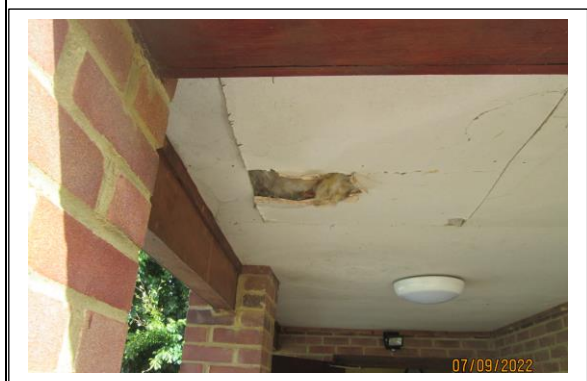
Photo 10 – Damage to ceiling in main entrance
